Civil Action No. 5:15-cv-273

EXHIBIT 1

Quality Loss Assessment LLC

Premium Report

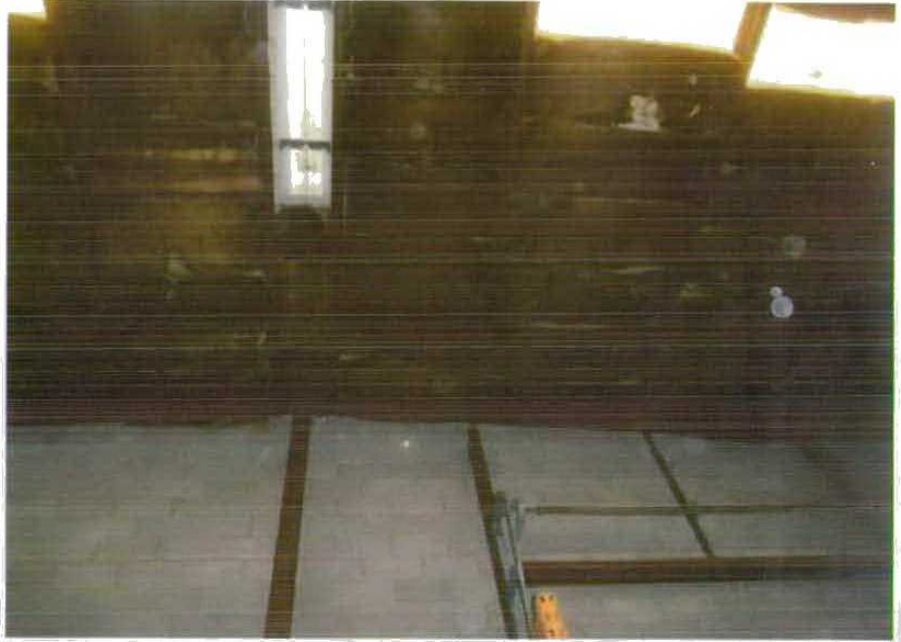
- 51 WET INSULATION
Date Taken: 3/17/2015
Taken By: CORY GARZA

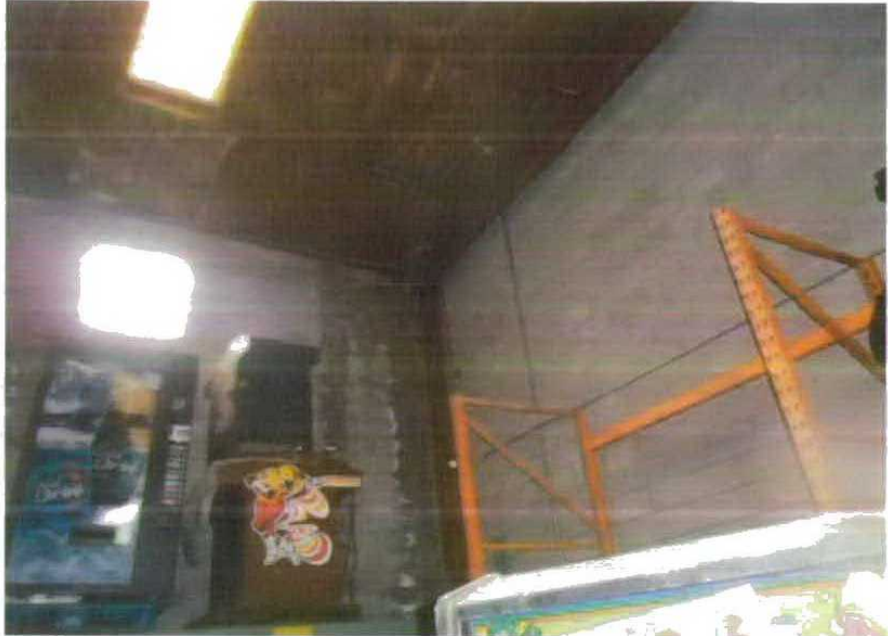
49 WET INSULATION

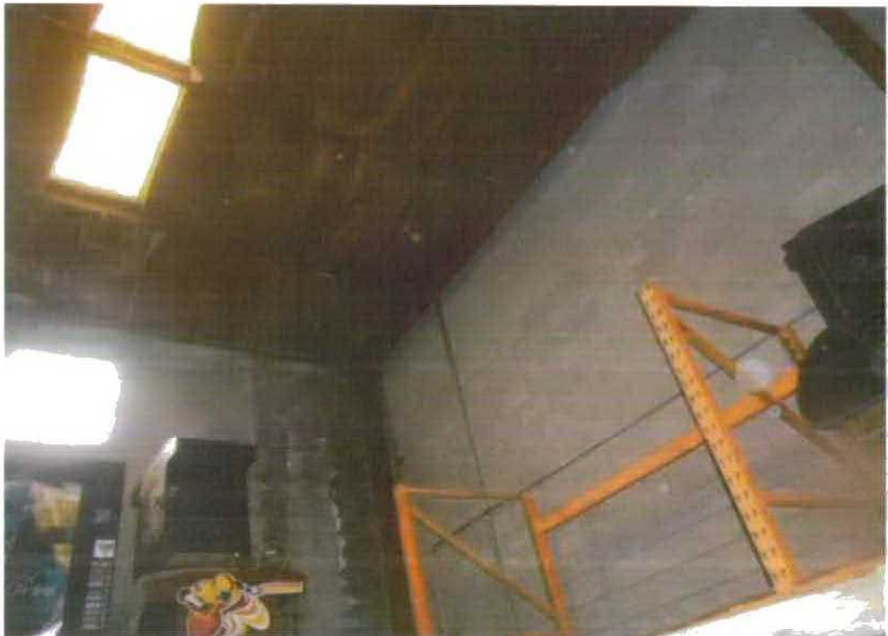
50 WET INSULATION

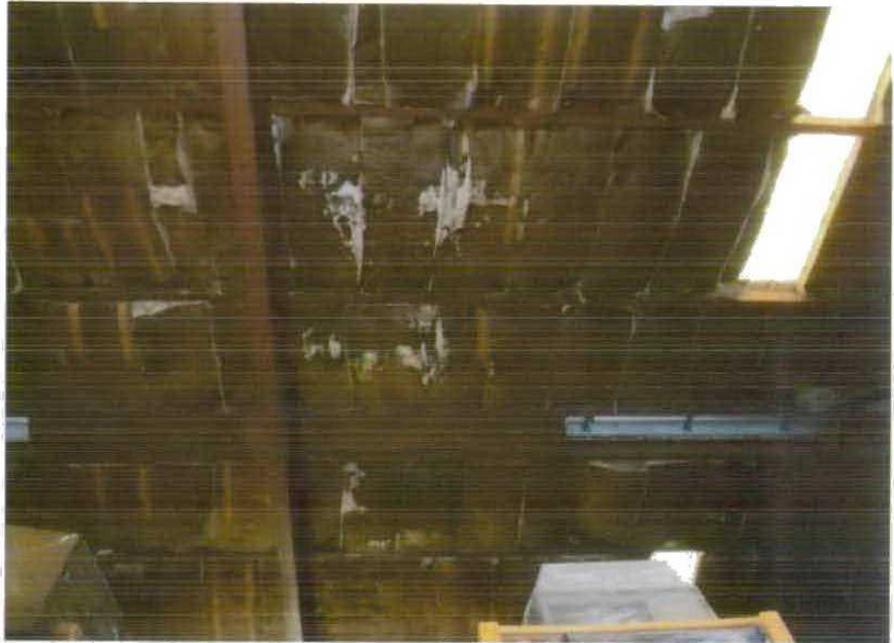
- 47 WET INSULATION
Date Taken: 3/17/2015
Taken By: CORY GARZA

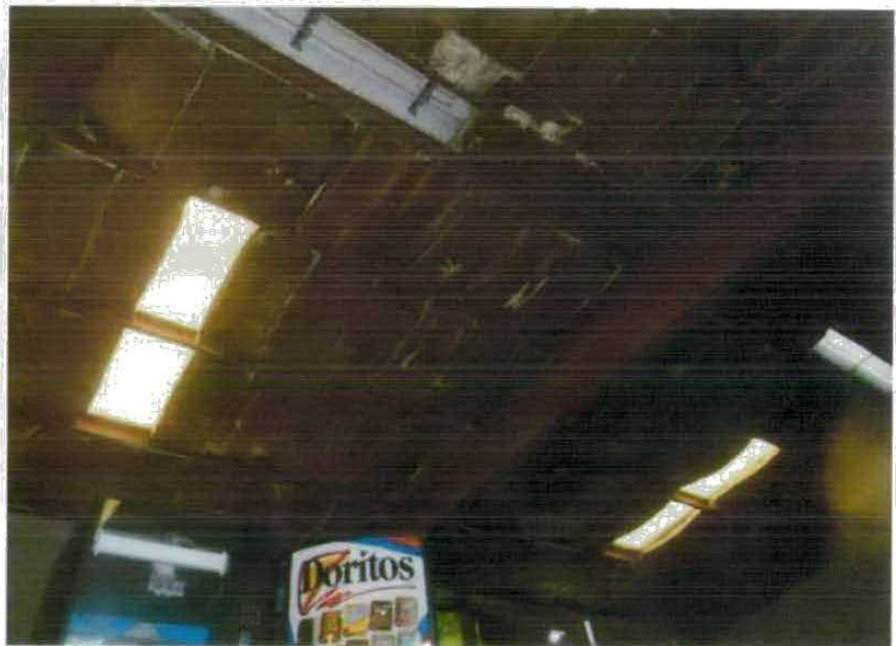
- 48 WET INSULATION
Date Taken: 3/17/2015
Taken By: CORY GARZA

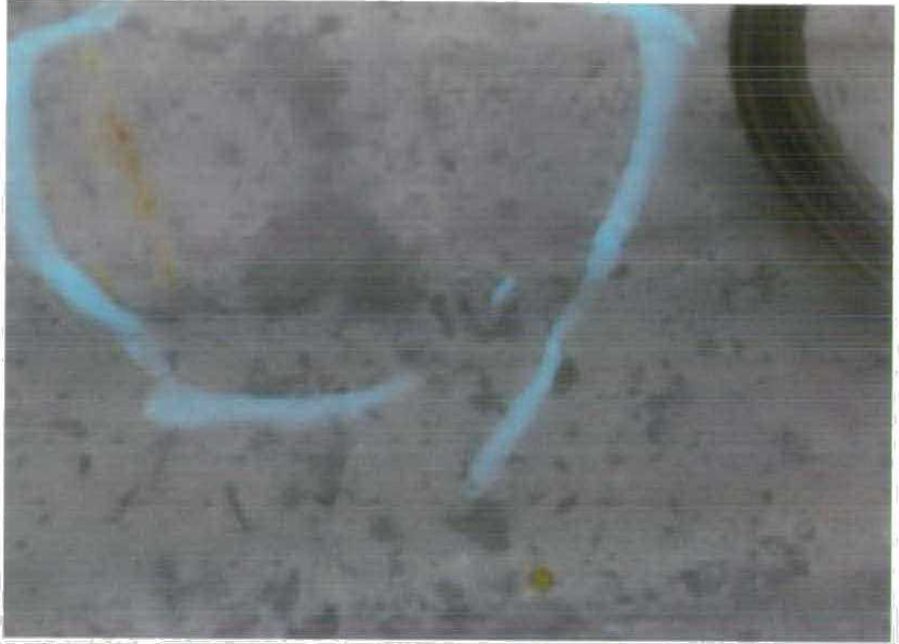
11 LEFT

HAIL HIT

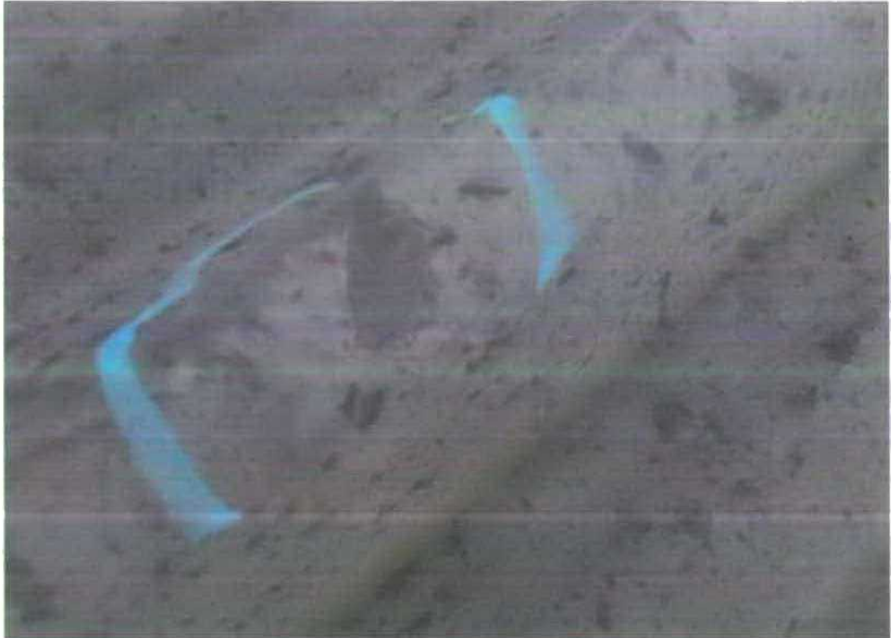
9 LEFT

HAIL HIT

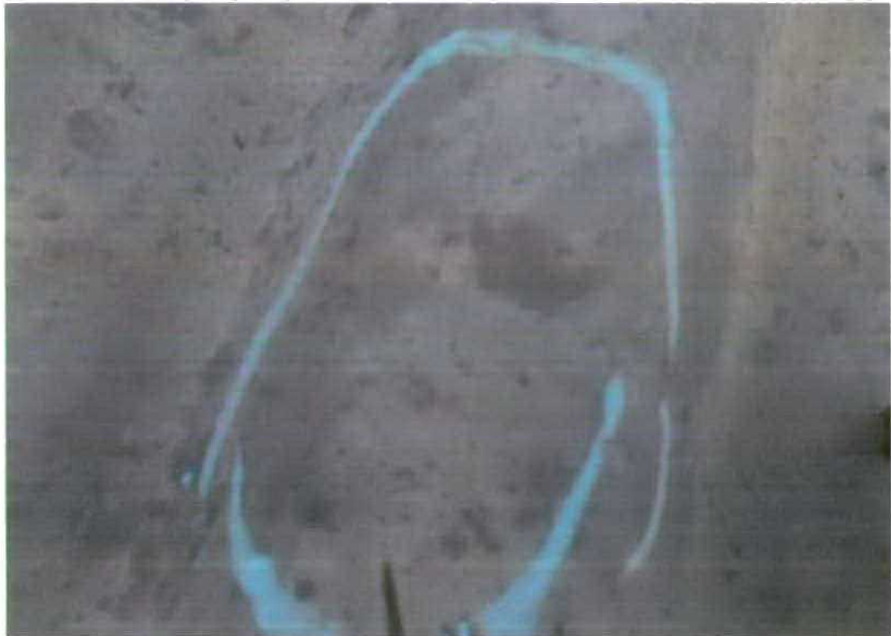
10 LEFT

HAIL HIT

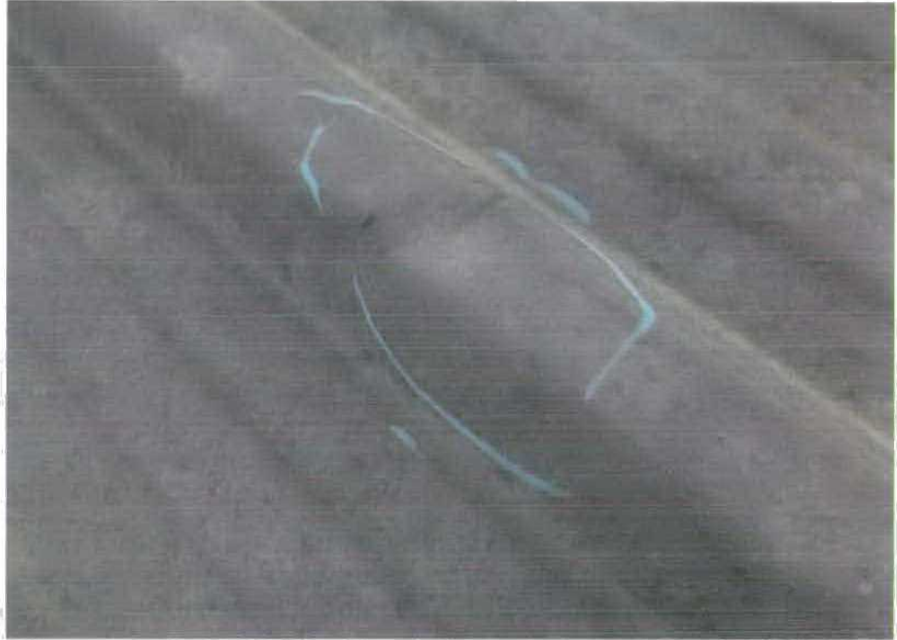
7 RIGHT

HAIL HIT

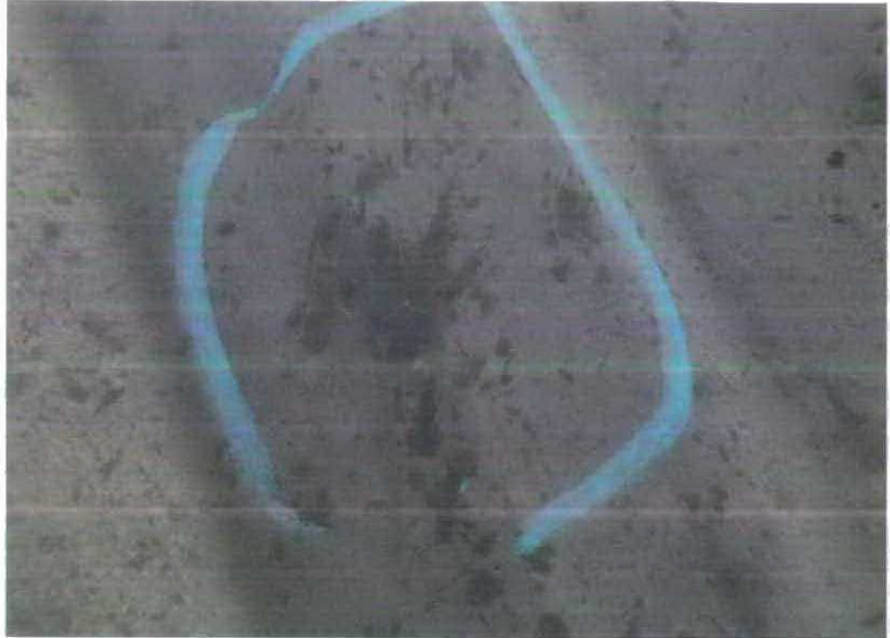
5 RIGHT

HAIL HIT

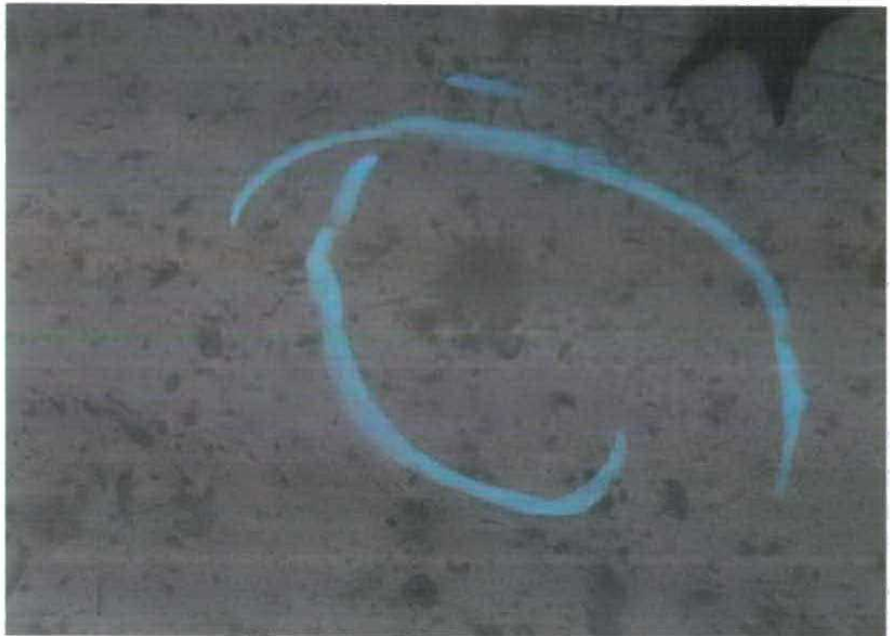
6 RIGHT

HAIL HIT

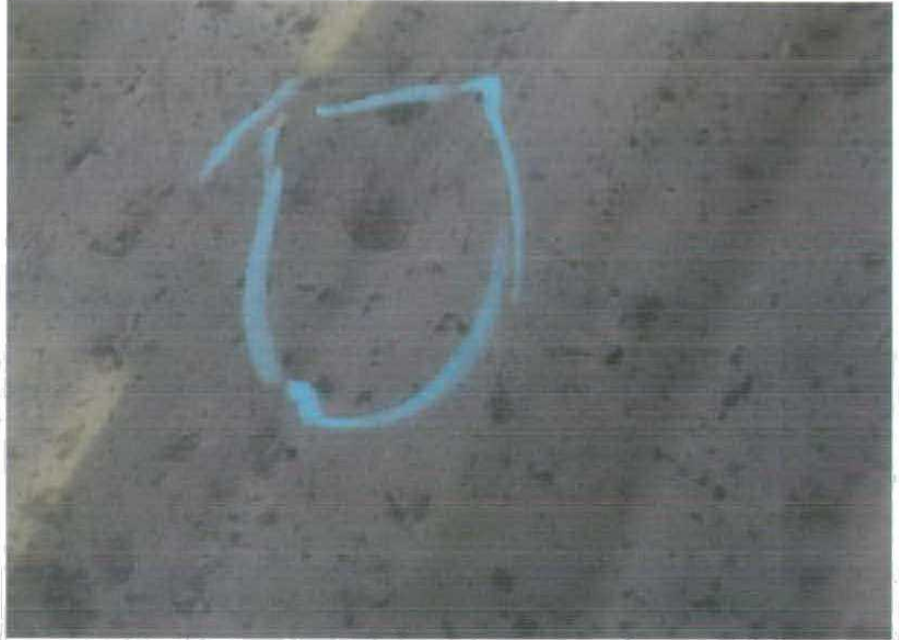
- 3 RIGHT
Date Taken: 3/25/2015
Taken By: CORY GARZA
HAIL HIT

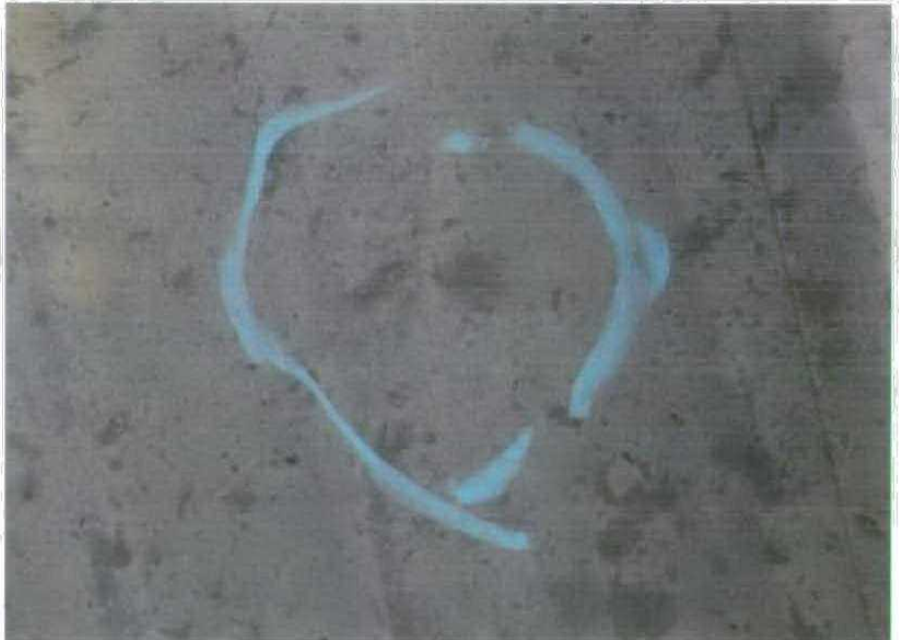
- 4 RIGHT
Date Taken: 3/25/2015
Taken By: CORY GARZA
HAIL HIT

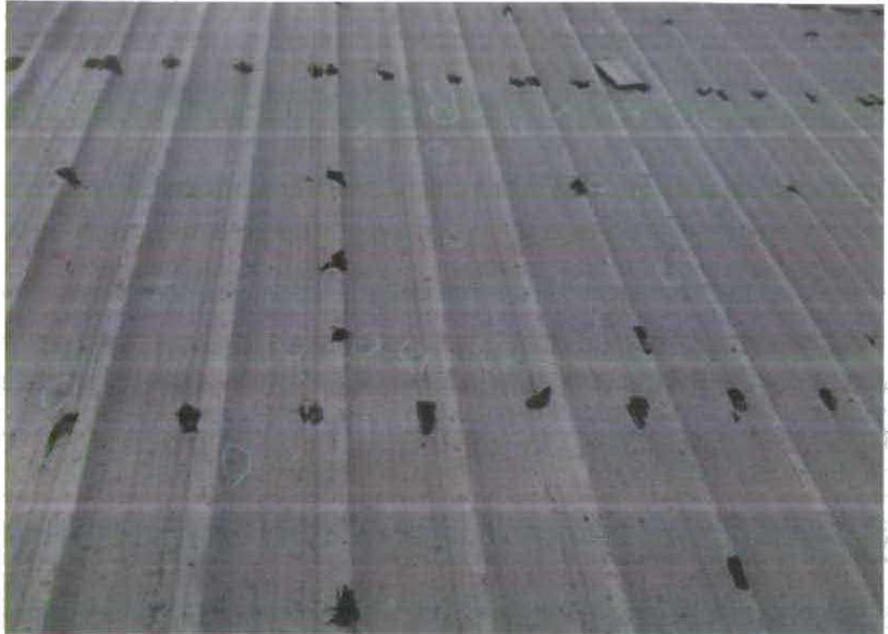
1 RIGHT

10 HAIL HITS PER SQ

DESCRIPTION	QNTY	REMOVE	REPLACE	TOTAL
1. Remove Metal roofing	6,072.00 SF	0.36	0.00	2,185.92
2. Metal roofing	7,000.00 SF	0.00	3.94	27,580.00
3. Remove Batt insulation - 10" - R30 - paper faced	6,072.00 SF	0.26	0.00	1,578.72
4. Batt insulation - 10" - R30 - paper faced	7,000.00 SF	0.00	1.29	9,030.00
Totals: Roof				40,374.64

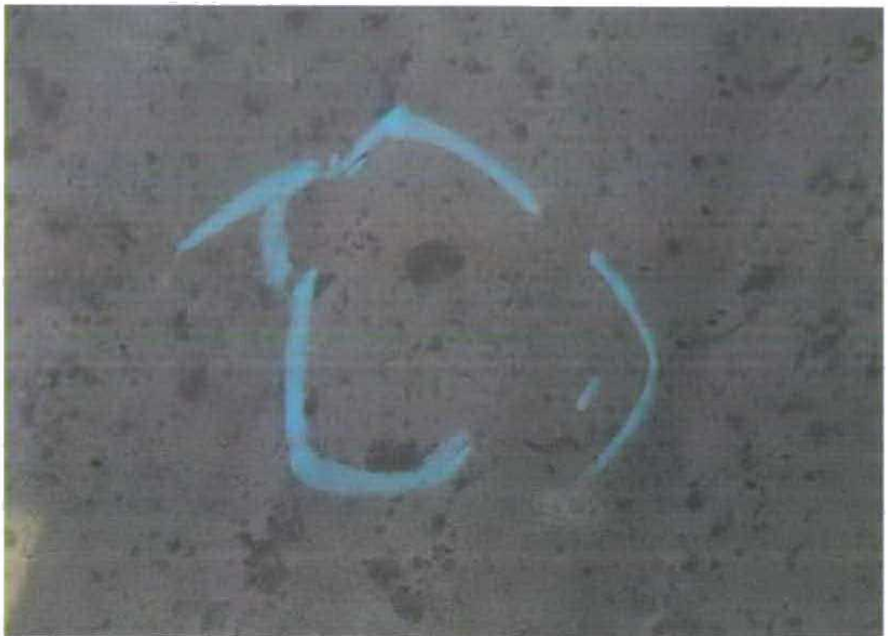
2 RIGHT

HAIL HIT
